Bureau of Mines Report of Investigations/1987

Analysis of Cutter Roof Failure Induced by Clastic Dikes in an Underground Coal Mine

By Eric R. Bauer and John L. Hill III

Report of Investigations 9117

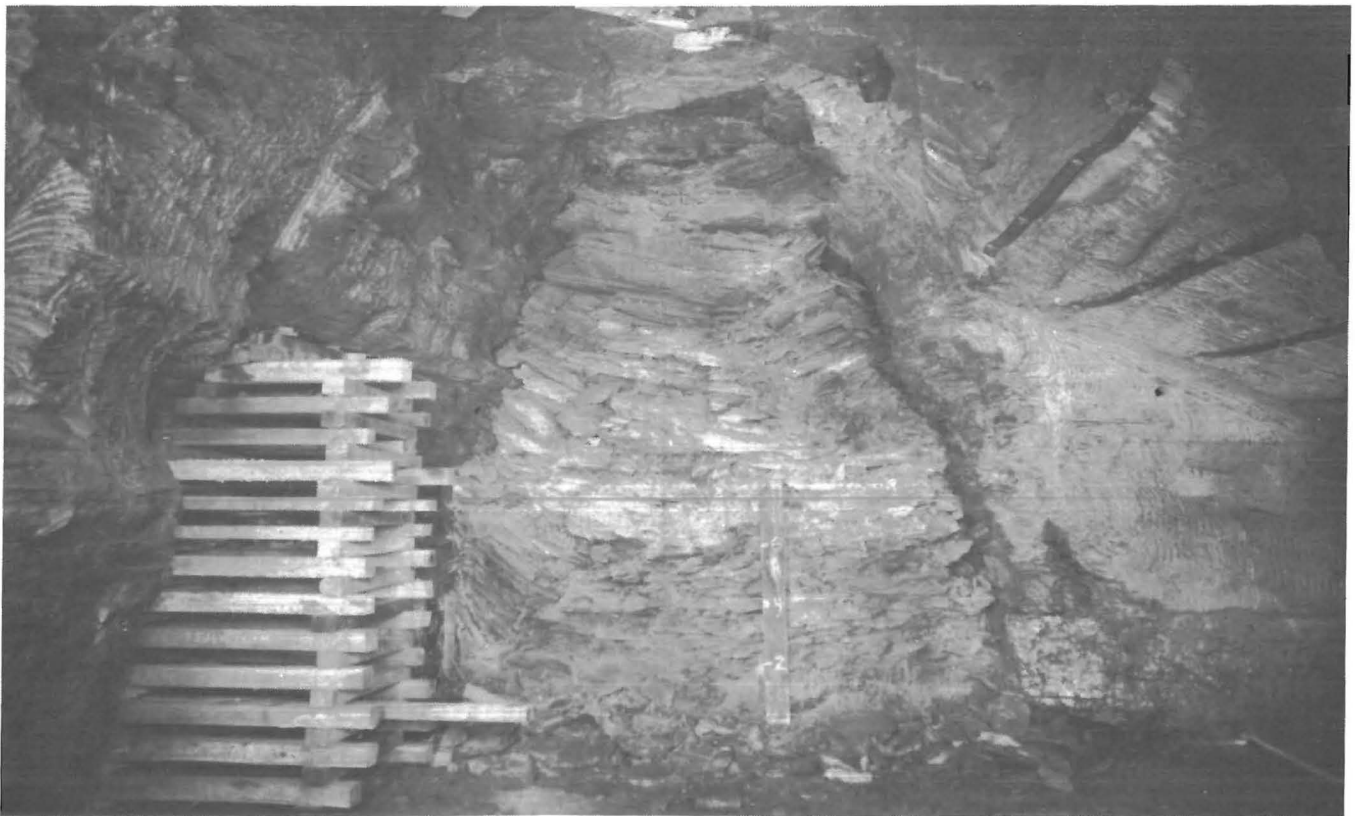
Cutter roof failure begins as a fracture along one or both roof-rib lines of an entry or crosscut and propagates nearly vertically into the roof (fig. 1). When the fracture extends above the anchor horizon of the roof bolts, or deflects along a weak bedding plane, massive roof failure may occur. Figure 2 is an example of initial cutter failure, and figure 3 illustrates the end result of such cutter development.

FIGURE 3.—Typical roof fall resulting from cutter failure (8).

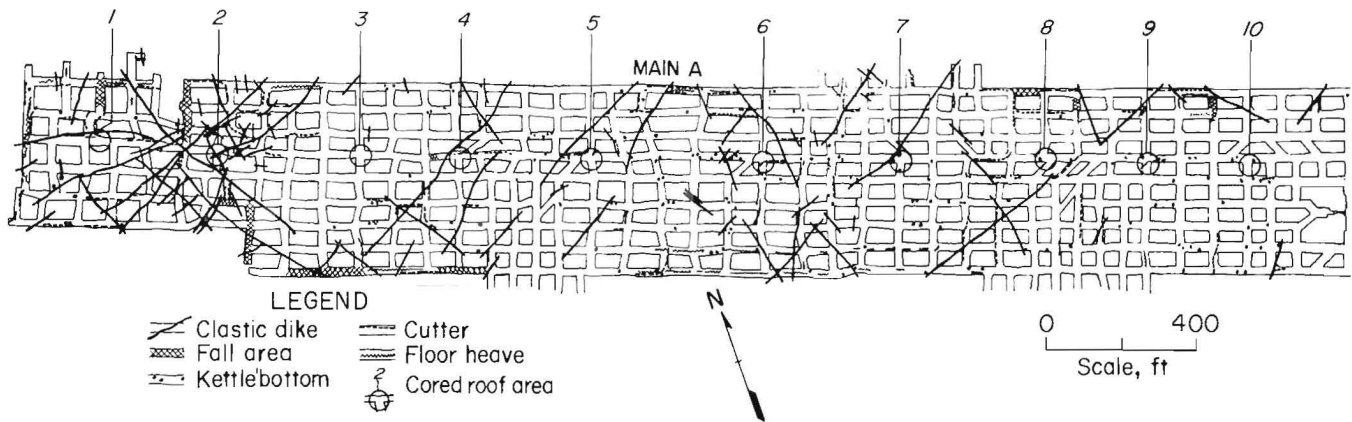
Detailed mapping of geologic features and deformation during cutter development was conducted in the Main A headings from the shaft to the face. Figure 6 is an example of the mapping and illustrates the relation of geologic features to roof failure. Clastic dikes (or clay veins), ranging in thickness from 1 ft of claystone matrix with fragments of shale and coal to a thin film of calcite or clay, are the primary roof-failure-initiating geologic features. Clastic dikes in areas overlain by channel and splay sandstones were filled with fine sand and silt instead of claystone. In some instances, infilled fractures and joints were by accident labeled clastic dikes because of similar appearance. The dikes

FIGURE 6.—Results of detailed mapping of the Main A headings (9).

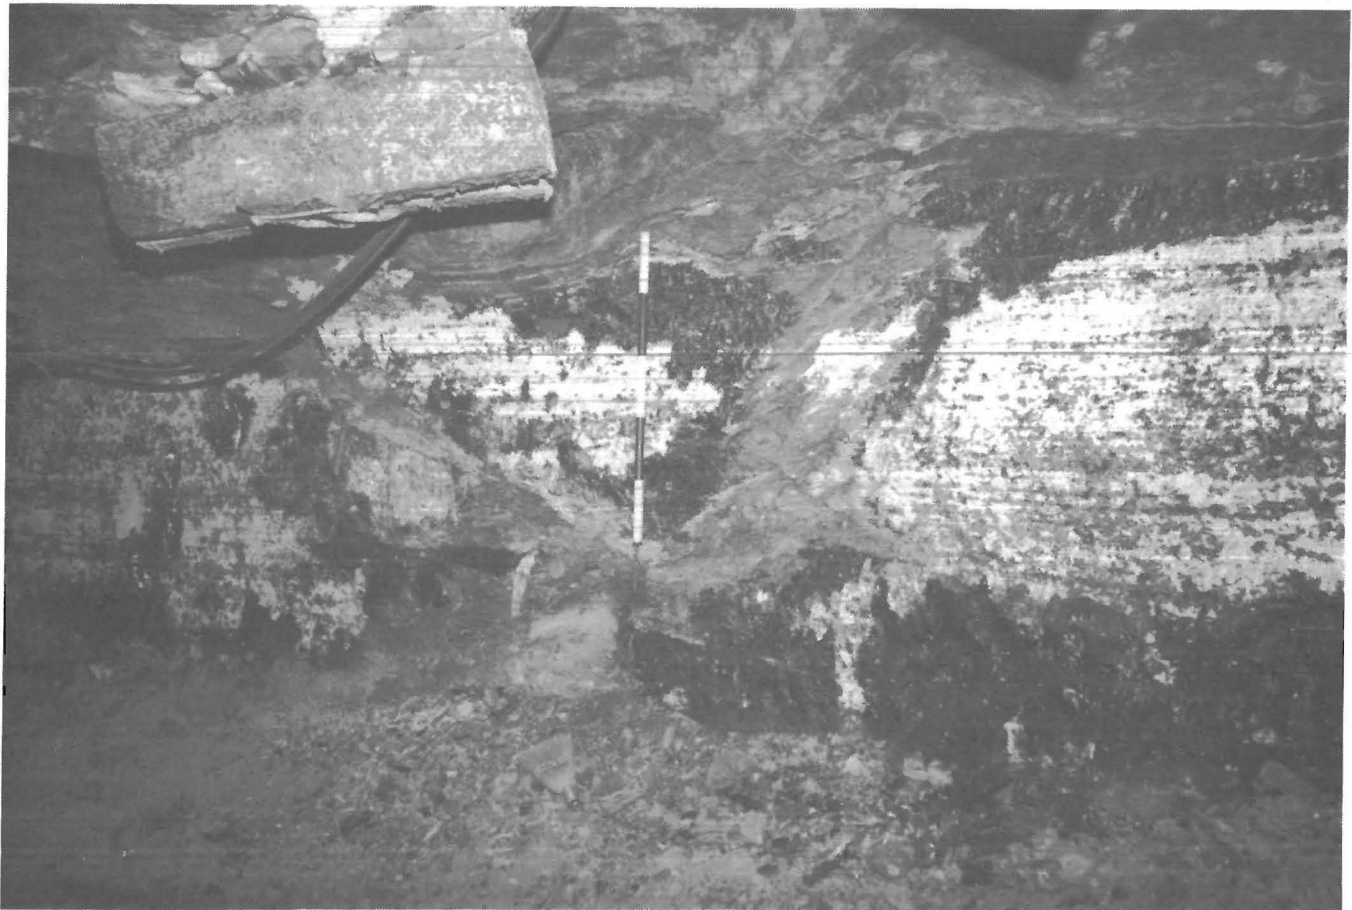
FIGURE 7.—Example of a clastic dike in both the mine roof and coal seam. (Courtesy F. E. Chase, BuMines, Pittsburgh, PA.)

exposed in roof falls extend as high as 26 ft into the roof rock and penetrate the coalbed at various angles. Figure 7 is an example of a clastic dike that has intersected both the mine roof and the coal seam. Few dikes reached the floor rock, suggesting an intrusion from above

the coalbed. Fractures and slickensides in the roof were associated with clastic dikes, and slickensided surfaces were often marked with horizontal striations.
